1 Town of Placentia, Newfoundland, Water Resources Infrastructure

1.1 Background

Water resources infrastructure vulnerability was one of four priority areas selected for review as part of the First National Engineering Vulnerability Assessment.

The Town of Placentia, Newfoundland, was chosen as the focus for one of the two water-resources case studies.

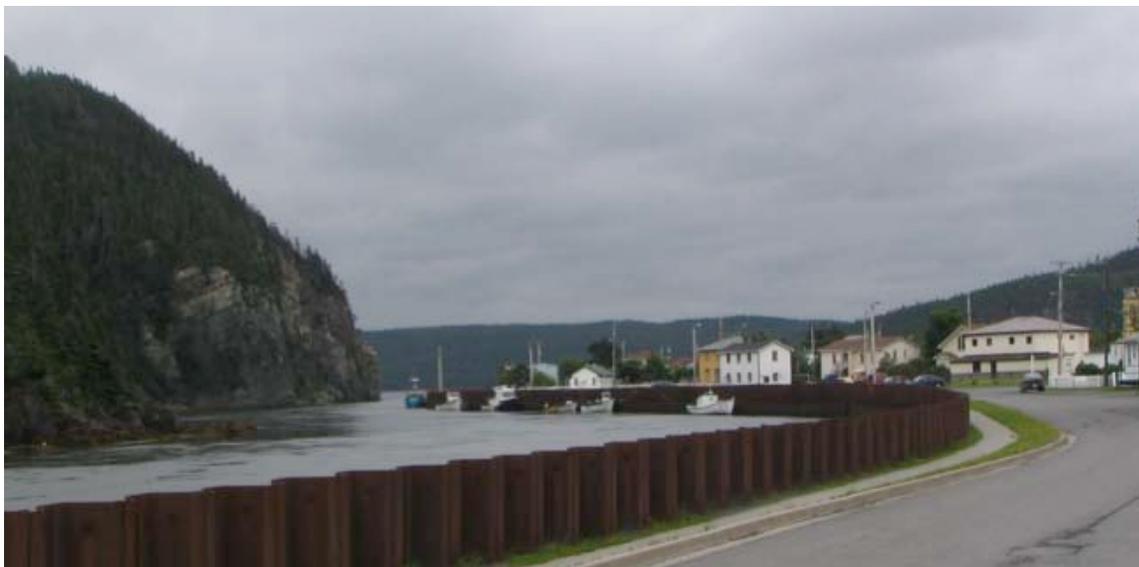
Figure A- 7 Floodwall

The steel sheet pile floodwall was constructed in 1993 along the back of the peninsula (northeast) of the newer portion of the Town of Placentia. The floodwall is build at a location where the geodetic elevation is 0m and typical tide (1992) is 1.2m under calm conditions. The infrastructure runs parallel to and between the main beach and a road.

The top elevation is 2.2m at typical sections of the floodwall, which has been effective in conveying the deflected storm-surge water away from the town.

It is noted that insufficient information is available but the potential does exist for a wave up to 5m high, or about 3m higher than top of the floodwall rolling up against it. Given the potential that already exists for a large wave to pass over the top of the floodwall, an additional increase of 10% in the level of wave water resulting from climate change is not considered an unacceptable threat to the performance of the floodwall.

Corrosion represents the most likely challenge to the floodwall's integrity (the town has proposed a \$300,000 cathodic protection system).

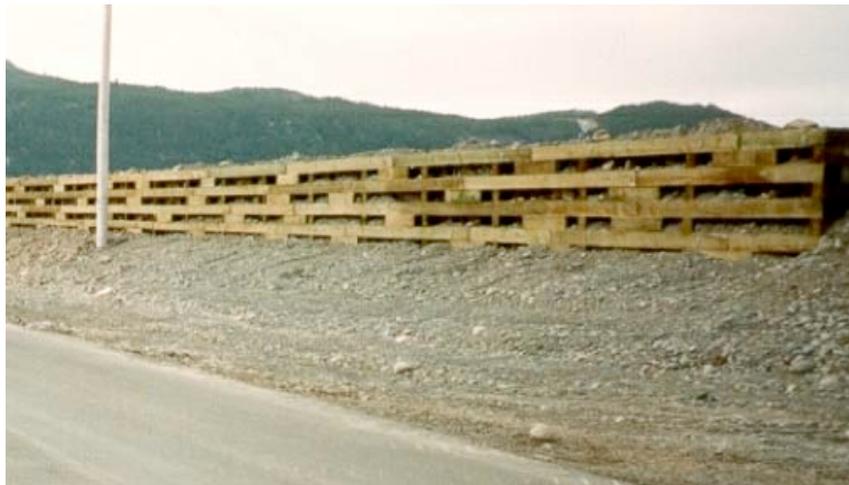
Figure A- 9 Breakwater

The breakwater is owned by the Town of Placentia and located along the west side of the main community, including the downtown area. The breakwater is constructed from stone, used creosoted railway ties, and pressure-treated wood in one portion. A boardwalk runs along the top. The breakwater, which receives continuous wave action, runs parallel to the main beach along Beach Road and forms the western limit of development for the downtown peninsula section of the Town of Placentia. The breakwater deflects storm surge seawater along the perimeter of the downtown peninsula. The typical top elevation of the breakwater is 5.8m and under normal conditions the top of the breakwater is between 2 and 4m above beach sediment on the seaward side.

A catastrophic failure of the breakwater would flood portions of downtown Placentia. Although spray and slush have reached the adjacent road, to date the breakwater has prevented flooding.

According to the consultants, insufficient human, equipment, time, opportunity and financial resources are being directed toward the breakwater. Based on the defined performance measures, specific recommendations are made to deal with:

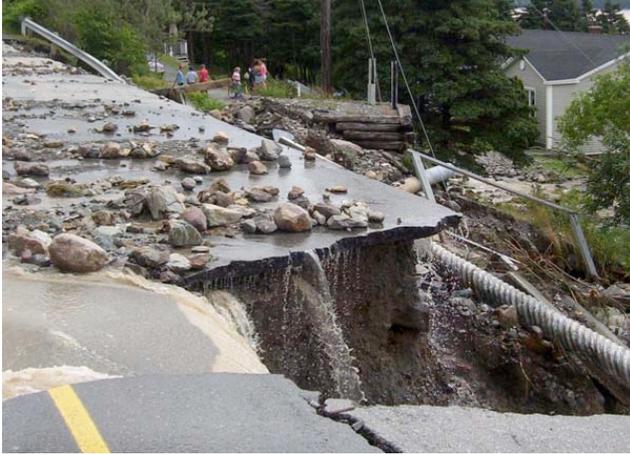
Figure A-10 Dunville Road

To one side of the road is a steep slope with some residences, small evergreen trees on minimal soil cover, and outcrops of bedrock. There are some barren patches to the tree cover. The forest is not currently logged, but was in the past, and when the exposed soil blew away, barren patches without tree cover resulted. To the other side of the road, sloping downward steeply towards the water, are more residential homes. The road is almost perpendicular to the water runoff route.

The area has been subject to flooding events, partially and temporarily blocking culverts (with designs based on 1:100 year water flows) and water build-up along the upslope of the road. Results (including when post-tropical storm Chantal brought 200mm of rain to the area in August 2007) have entailed washout of portions of the road, need to replace sections of the road and culverts, flooding of homes and temporary isolation of part of the community.
