Adapting to Climate Change

Appendix B-6
Thermosyphon Foundations, Northwest Territories and Yukon

Flat Loop Thermosyphon Foundations in Warm Permafrost

prepared by:
Igor Holubec, Ph.D., P.Eng
I. Holubec Consulting Inc.

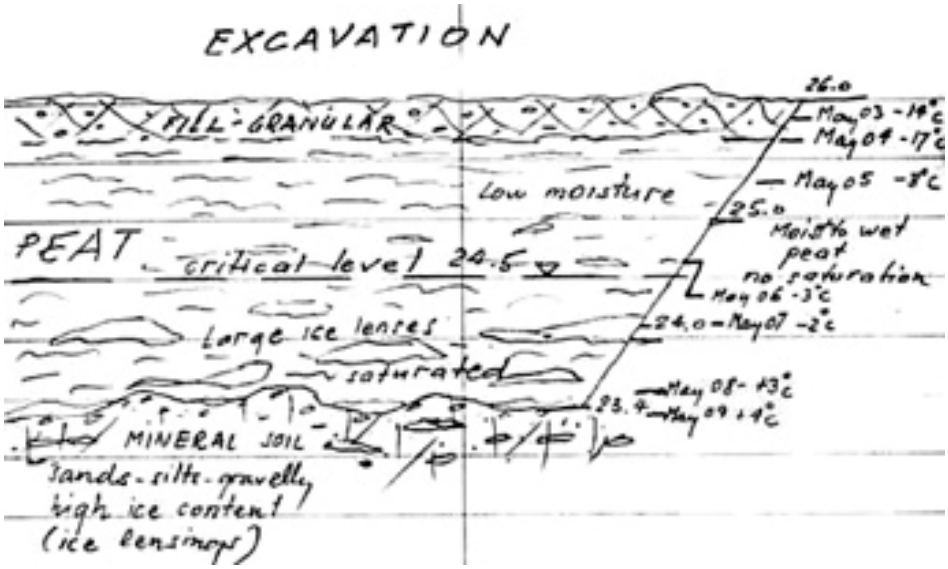
Figure 1. Excavation log at Inuvik Aurora College (Field notes from AFC).

An example of difficult ground conditions is shown by a log prepared during excavation of the natural ground at Inuvik during the construction of the granular pad for the thermosyphon foundation at Aurora College in Inuvik in 1992 shown in Figure 1. Photo 5 and Figure 1 illustrate the extra care that needs to be exercised in the design and construction of foundations in ice rich soils.

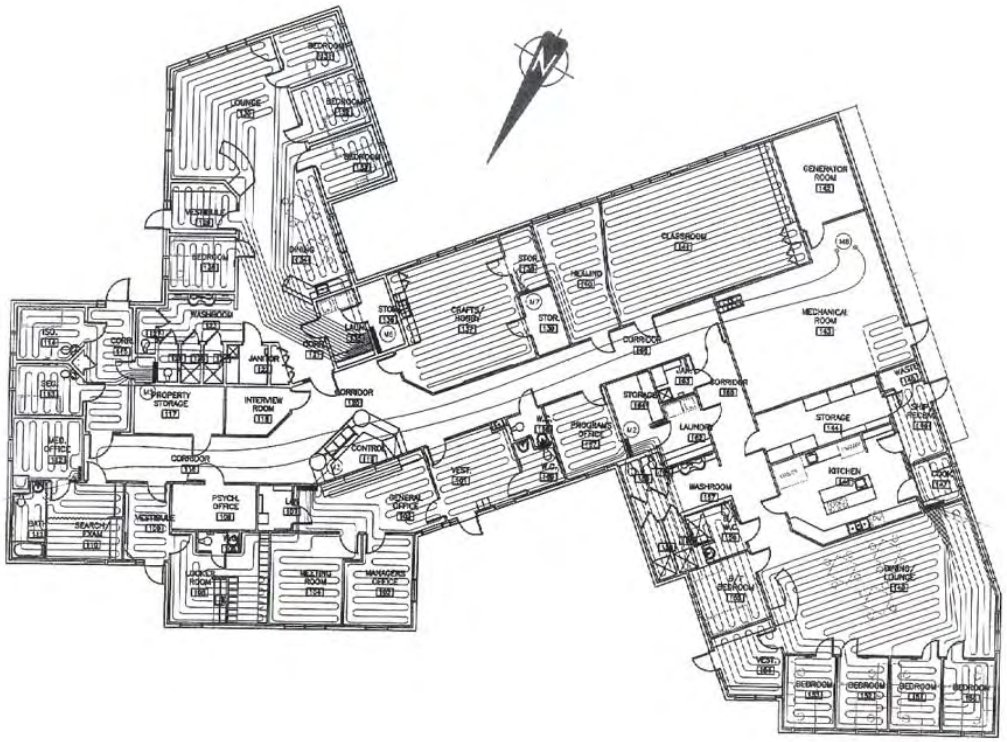
Figure 27. Room and radiant tubing layouts at the FYOF, Inuvik, NT

The building is heated with radiant piping in the slab floor. The heating pipes are located near the bottom of the slab and have been operating at higher temperatures for which was not designed. This introduced much greater heat to the foundation than the thermosyphons were designed to remove.

The above led to the addition of radiators and installing a refrigeration system to freeze the foundation. It took 3 years to finally freeze the foundation.

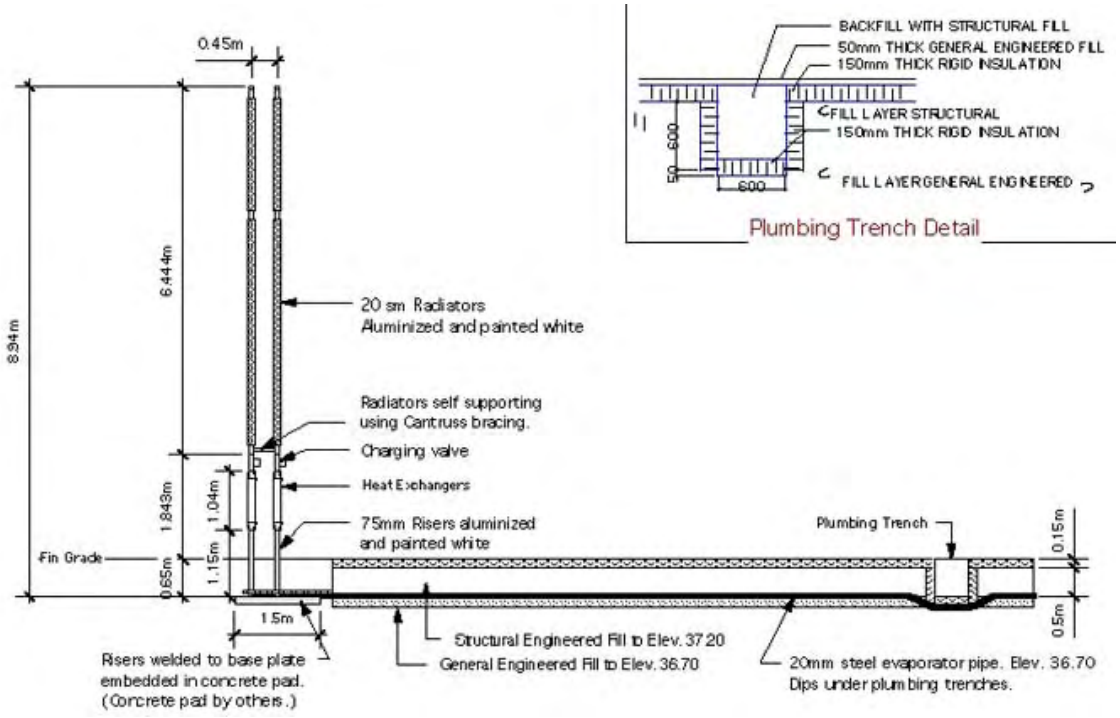
Figure 28. Section showing the evaporator pipe in respect to the slab-on-grade foundation, insulation and the services (plumbing) trench, FYOF, Inuvik, NT

Finally, an additional flaw of the thermosyphon pad design was poor perimeter drainage around the granular pad. Surface water introduced into the gravel pad resulted in frost heave during the winter and thaw settlement the following summer. This resulted in cracking of the interior drywalls and minor electrical and plumbing failures around the building.

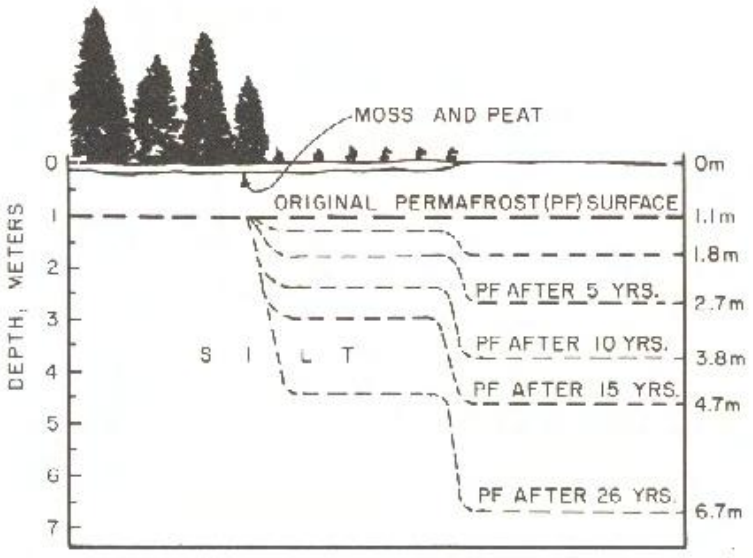
Figure 32. Removal of tree and peat cover resulting in thawing of ground in discontinuous permafrost.

It is necessary to consider the effect of changing the environment around the site when designing foundations of buildings in near discontinuous permafrost with ice rich soils as is the case at Inuvik where the ground temperatures are in the vicinity of -2.5°C. At this location the tree and peat cover provide considerable insulation to the underlying ground and their removal, or compression, will increase the annual thaw depth considerably. This is illustrated by Figure 32 from a classic paper by Linell (1973).

The removal of trees and compression of the peat by fill around the FYOF building has deepened the annual thaw of the ice rich till that resulted in considerable fill settlement and damage to services as illustrated in Figures A20 & A21. The thaw depth around the FYOF building will not be as deep as illustrated in Figure 32, but it has been sufficiently deep to have caused the damage.

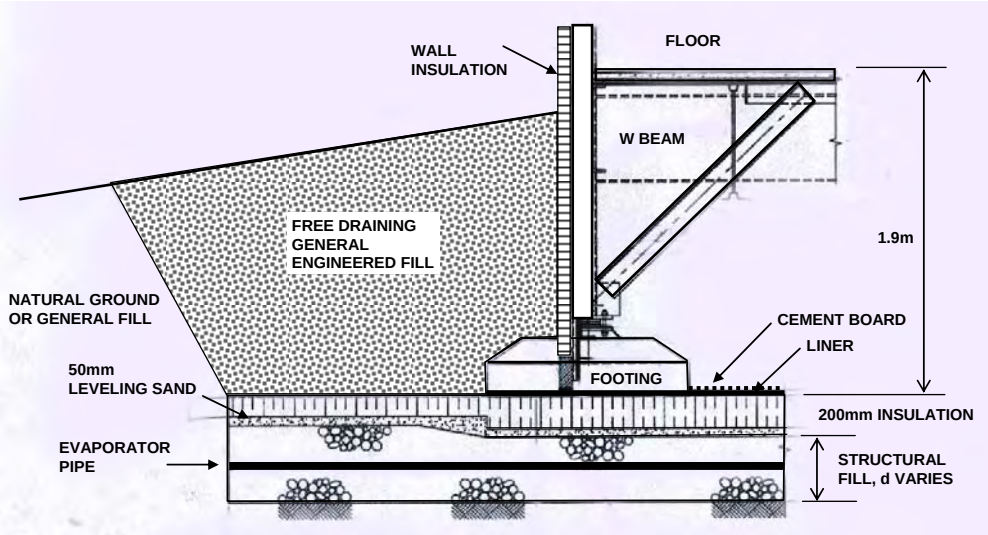
Figure 34. Foundation design at building perimeter for hospital, Inuvik, NT

The native soil stratigraphy consisted of sandy silt with ice lenses. It was decided to excavate to a level to remove the heterogeneous fill and peat and locate the granular pad on the natural ground. The hospital was to be founded on shallow spread footings resting on a thermosyphon granular pad. A crawl space would be provided between the thermosyphon pad and the base of the floor so that services could be hung from the floor beams. The floor of the building was to be level with the surrounding ground level to provide easy access. This resulted in the crawl space being designed below the surrounding ground. The foundation design is illustrated on Figure 34.

These ice mounds developed because the summer surface and ground water was able to seep through the Free Draining General Engineered Fill shown in Figure 34 and penetrated through the insulation joints into the interior where it flowed just beneath the liner into the overall crawl space. Free water was attracted to local areas to grow mounds when the thermosyphon started to freeze again in the fall. Water supply was available due to the following reasons:

- Site visit to the Hospital on September 7 showed that there was hardly any slope or none at all from the wall to drain surface water.
- Design as shown in Figure 34 will not prevent surface and ground water to penetrate the crawl space. The fill should have either have been low permeability

2) The geotechnical and civil engineers who develop the foundation drawings should prepare construction drawings and specifications that prevents surface and ground water penetrating the thermosyphon foundations. Also a functioning perimeter drainage and sump should be provided should water pass through the seepage controls.

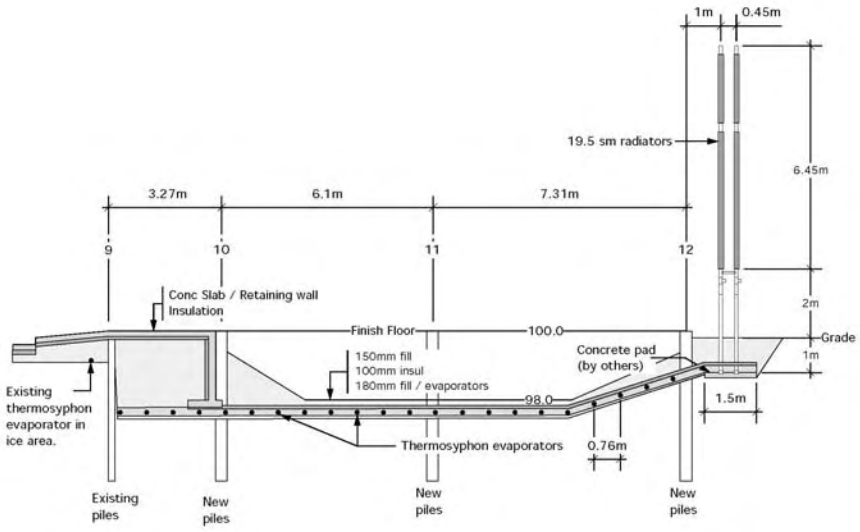
Figure 42. Foundation section at the building addition, Dawson City ice rink (Arctic Foundation).

Evaporator piping for the building addition (beneath the heated dressing and washrooms) was installed in October 2000. The spacing of these pipes was narrower to take into account the heated surface assumed to be at 20°C; the pipes were spaced at 0.76m. The insulation was 100mm at both installations. A foundation section at the building addition is shown in Figure 42.

A dispute between the general contractor and owner resulted in all the work stopping and the building being closed in the fall of 2000. In July 2001 the evaporator pipes were covered with insulation but by this time the ground had thawed to a depth of 2.8m. It was decided not to proceed with the pouring of the concrete slab that year because of anticipation of further thaw and potential damage to a slab poured on a thawing ground. The closed building was heated to 11°C through the winter of 2001/2002 that reduced the efficiency of the thermosyphon system that was designed with surface temperature of 0°C. The owner decided to abandon the thermosyphon system beneath the ice rink.

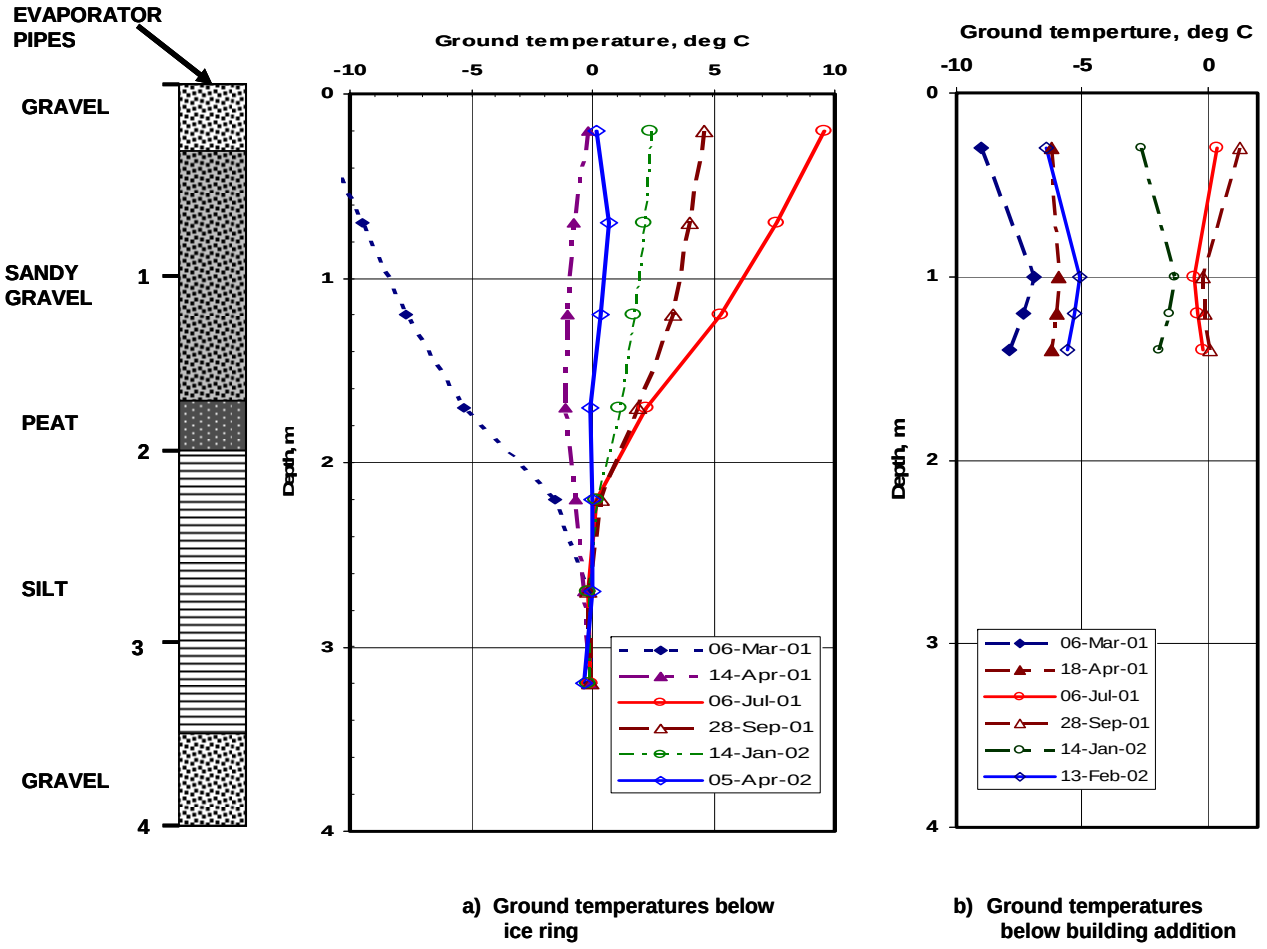
Figure 43. Ground temperature profiles at the ice rink and building addition, Dawson City Recreation Centre

The thermosyphon system was installed beneath the heated dressing and washrooms in November 2000. The design was based on the heated floor resulting in closer evaporator piping being 0.76m and with 150mm insulation thickness. This thermosyphon kept the foundation below this part of facility frozen as designed. Ground temperature performance at this project is illustrated in Figure 43.

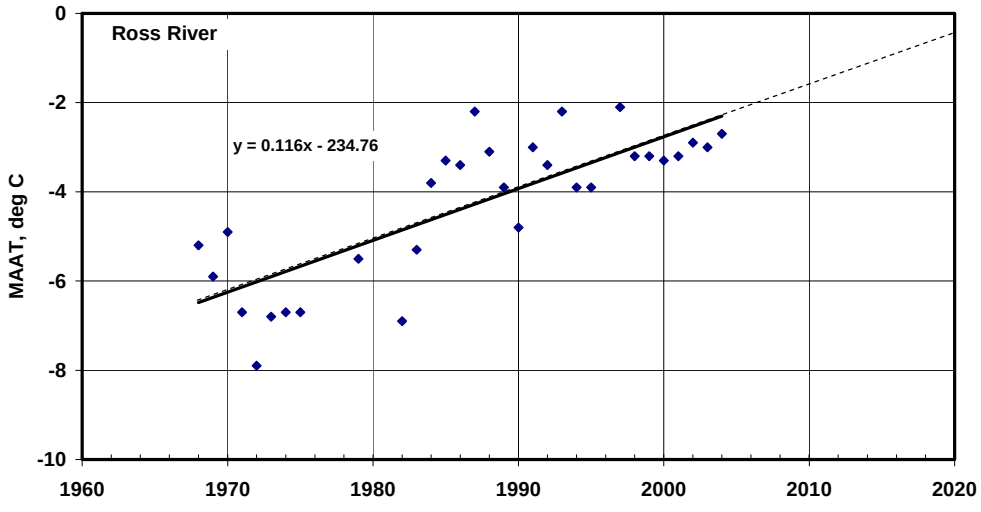
Figure 44. Mean annual air temperatures changes at Ross River, YK (Environment Canada)

Ross River has two thermosyphon foundation case histories; with the first one built in 1974 and the second 25 years later in 1999. Both of these projects are schools. Ross River is located about 400km southeast of Dawson City with a mean annual air temperature being about 1.5°C warmer than Dawson City. It is located in a glaciated valley that is underlain by about 5m of sand and gravel followed by at least 23m of ice rich silt (Haley 1981). The sand and gravel layer was judged to be thaw stable with a water content of about 5% and less than 10% of silt sized particles. The base of permafrost was measured at 28m. The mean annual air temperature is warming at Ross River from about -6.8°C in 1975 to -3.1°C in 2000 (Figure 44).

- Reaction of the ammonia gas with pipe or pipe compounds may have produced a gas that settled at the top of the radiator pipes and thereby reducing/preventing the ammonia gas condensing at the top of the vertical pipes with the radiators.
- Wide spacing of the evaporator pipes at 3m was inadequate to deal with the air temperature warming (Figure 44).

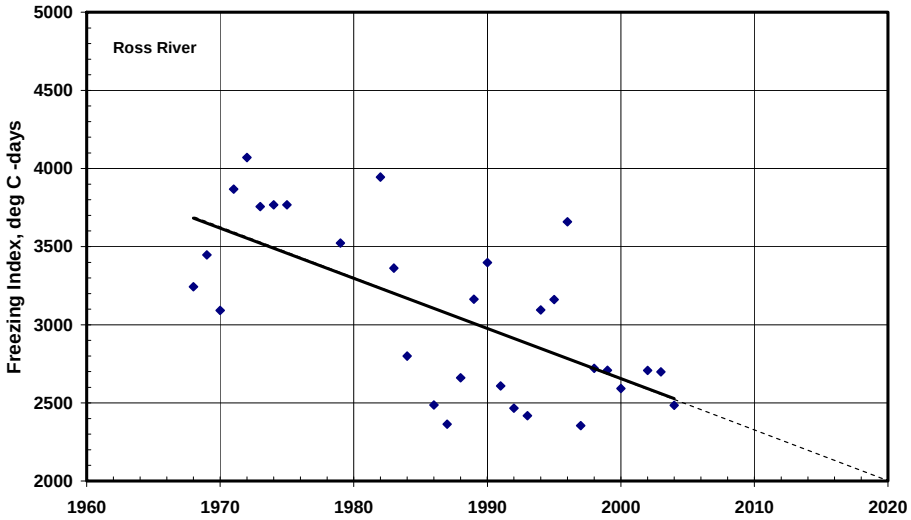
Figure 45. Freezing index change with climate warming at Ross River (Environment Canada)

While the warming of the mean annual air temperature warms the permafrost and decreases the depth to the base of the permafrost zone, it also decreases the freezing index that determines the amount of cooling the thermosyphon will produce. The historic decrease of the freezing index with time at Ross River is shown in Figure 45.

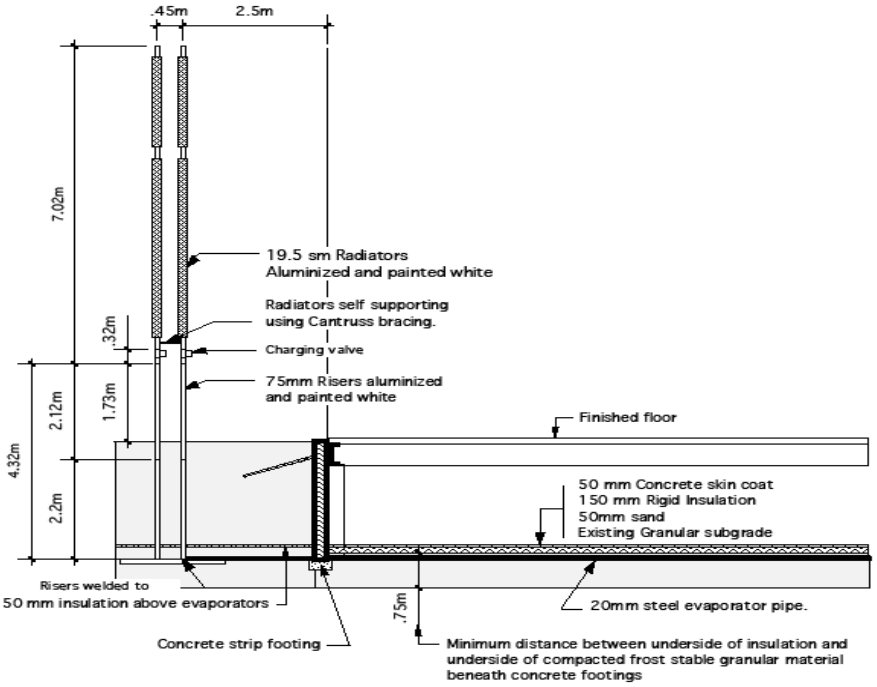
Figure 46. Typical flat loop thermosyphon section, Ross River School (Arctic Foundation 1999)

The foundation design was a flat loop thermosyphon foundation with a crawl space. The main floor of the school was slightly elevated above the surrounding ground and the base of the floor of the crawl space being about 2m below the finished floor (Figure 46). The evaporator pipes were spaced between 0.9m to 1.7m, depending on the length of the evaporator pipe, and were filled with carbon dioxide.

The likely deep advance of the thaw front into the thaw compressible silt became evident by differential settlement during the first year after construction (Blum 2008).

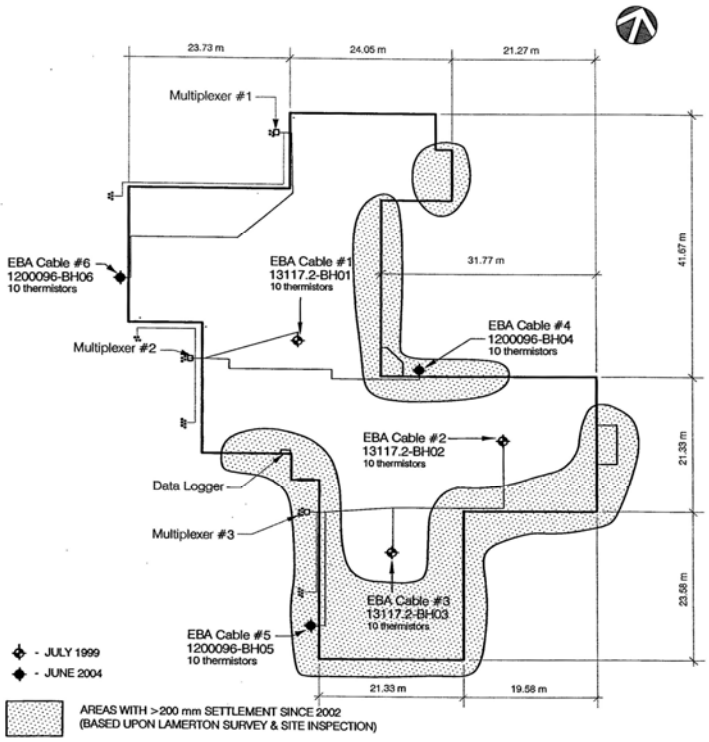
Figure 49. Settlement plan at Ross River School in 2005 (EBA 2005)

Differential settlement of the school was being observed within a year of construction. Fortunately, the school base was designed so that any differential settlement could be corrected. The settlement became a problem by 2005 when a maximum settlement of 75mm was observed. Corrective measures were made in 2006 to improve the cooling system and thereby reduce or eliminate the settlement. The corrective measures included the addition of thermosyphon cooling around the outside perimeter of the building, maintaining the air temperature within the crawl space cooler and installing better insulation on the outside crawl space walls. Results of these improvements are not known.

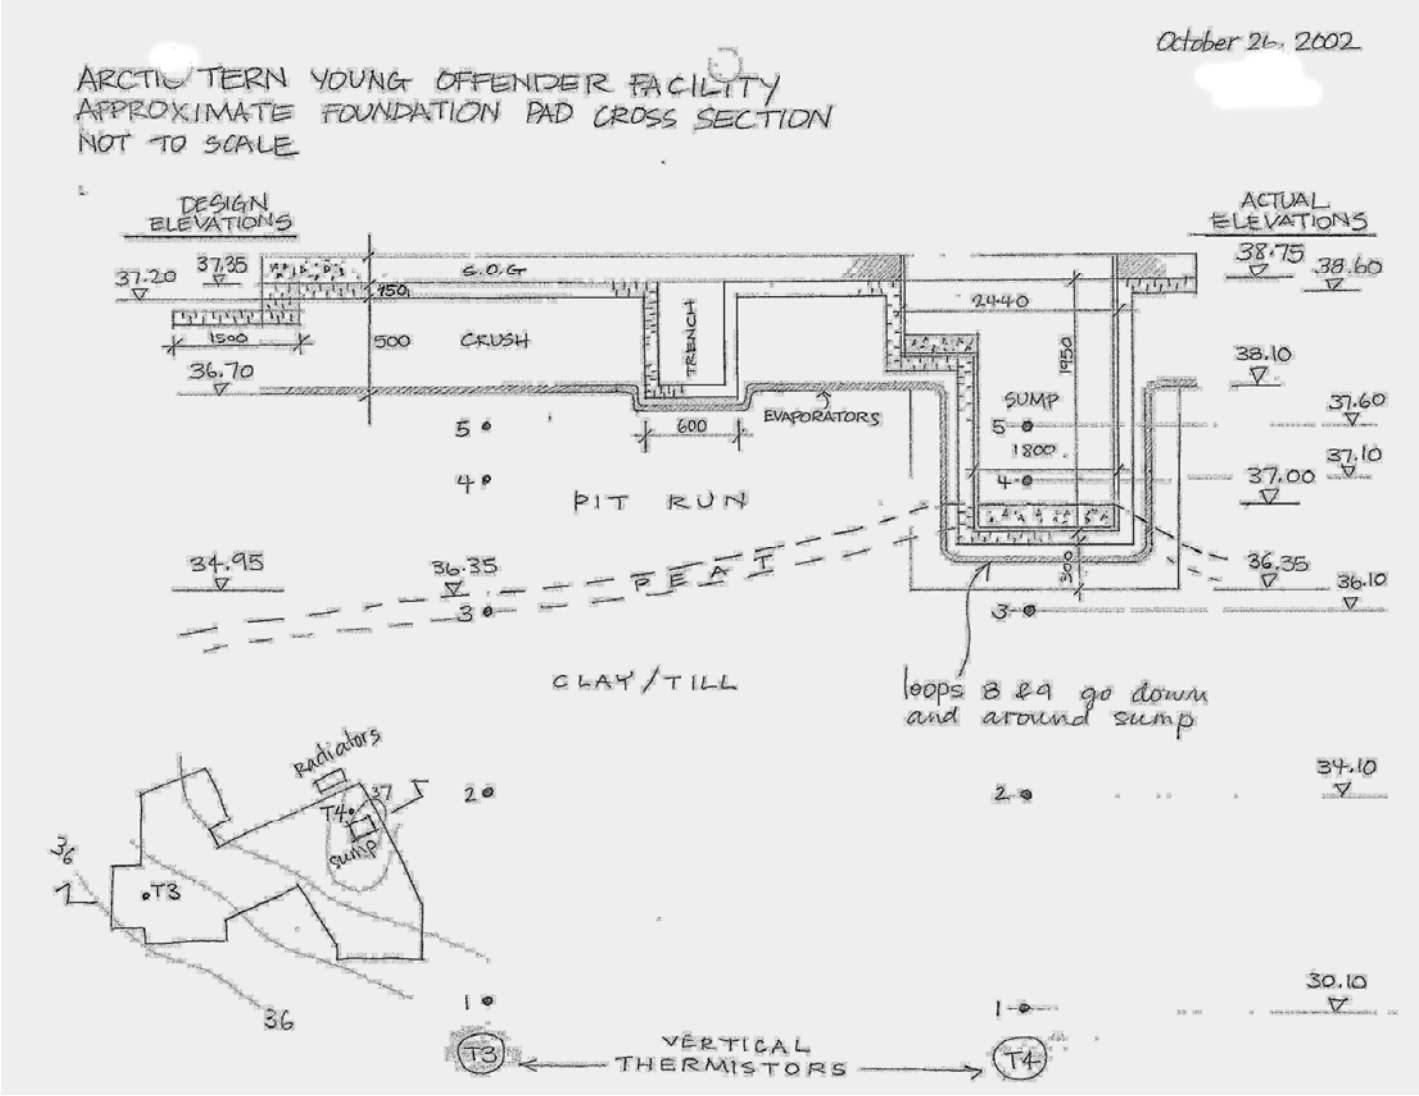
Figure A 15. Schematic of the foundation pad cross section (Public Works & Services files)

The Inuvik FYOF project represents a multiple design and construction inadequacies that lead to the settlement of various parts of the building, cracking of the floors and walls and blocking of the sanitation pipe by developing a negative slope. The poor performance of the building was due to:

5) Compression of the peat by the fill resulted in deeper thaw penetration into the ice rich soil around perimeter of the building. The thickest fill placed during the warmest part of year on the north of the building provided a considerable heat source that caused deep thaw of the existing underlying ice rich till and thereby considerable fill settlement. Fill on the south and southwest was thinner, but it obtained extra heating at its slopes due to the southern sun exposure of the sloping surfaces.
